# Holiday Inn Runcorn Hotel

Wood Lane, Beechwood, Runcorn, Cheshire, WA7 3HA

## Access Guide

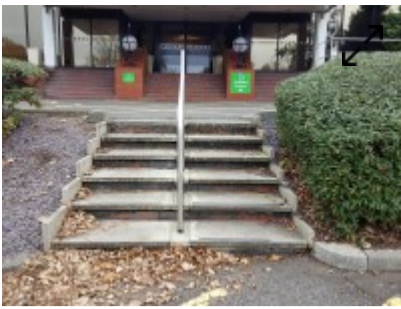
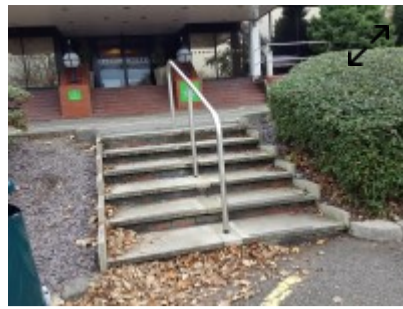
## **Step(s) (Car Park to Main Entrance)**

- There is a/are step(s) located leading from the car park to the main entrance.
- The step(s) is/are used to access The steps lead from the car park and access the area in front of the main entrance.
- There is/are 6 step(s).
- The step(s) is/are not clearly marked.
- The height of the step(s) is/are between 15cm and 18cm.
- The going of the step(s) is/are not between 30cm and 45cm.
- There is a/are handrail(s) at the step(s).
- The handrail(s) is/are in the centre of the step(s).
- Handrails are at the recommended height (90cm-100cm).
- Handrails do cover the flight of stairs throughout its length.
- Handrails are easy to grip.
- Handrails do not extend horizontally beyond the first and last steps.

- These steps can be avoided by using the drop off point at the main hotel entrance.

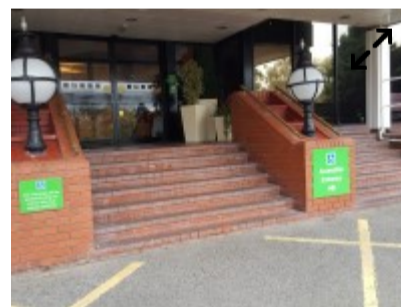
## **Outside Access (Main Entrance)**

- This information is for the entrance located at the front of the hotel.
- The entrance area/door is clearly signed.
- There is stepped access at this entrance.
- There is a canopy or recess which provides weather protection at this entrance.
- There is a dark mat or floor marking at this entrance that might be perceived as a hole.
- The entrance door(s) does not/do not contrast visually with its immediate surroundings.
- The bell/buzzer is not in a suitable position to allow wheelchair users to gain access.
- The height of the bell/buzzer is 140cm (4ft 7in).
- The main door(s) open(s) automatically.
- The door(s) is/are double width.

- The width of the door opening is 194cm.
- There is a second set of doors.
- The door(s) open(s) automatically.
- The door(s) is/are double width.
- The width of the door opening is 185cm.
- There is a member of staff available for assistance at this entrance.

- The step(s) is/are located in front of the entrance.
- There is/are 7 step(s).
- The step(s) is/are clearly marked.
- The height of the step(s) is/are between 15cm and 18cm.
- The going of the step(s) is/are not between 30cm and 45cm.
- There is a/are handrail(s) at the step(s).
- The handrail(s) is/are on both sides of the step(s).
- Handrails are at the recommended height (90cm-100cm).
- Handrails do not cover the flight of stairs throughout its length.
- Handrails are easy to grip.
- Handrails do not extend horizontally beyond the first and last steps.

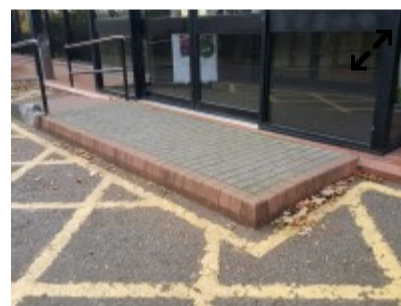
## **Outside Access (Side Entrance)**

- This information is for the entrance located at the right side of the hotel.
- The entrance area/door is clearly signed.
- There is ramped/sloped or stepped access at this entrance.
- There is not a canopy or recess which provides weather protection at this entrance.
- There is a dark mat or floor marking at this entrance that might be perceived as a hole.
- The entrance door(s) does not/do not contrast visually with its immediate surroundings.
- The bell/buzzer is not in a suitable position to allow wheelchair users to gain access.
- The height of the bell/buzzer is 138cm (4ft 6in).
- The main door(s) open(s) automatically.
- The door(s) is/are double width.
- The width of the door opening is 218cm.
- There is a second set of doors.
- The door(s) open(s) automatically.

- The door(s) is/are double width.
- The width of the door opening is 184cm.
- There is a member of staff available for assistance at this entrance.

- The ramp/slope is located to the left as you face the entrance.
- The gradient of the ramp/slope is steep.
- The ramp/slope is permanent.
- There is not a level landing at the top of the ramp/slope.
- There is a/are handrail(s) at the ramp.
- The handrail(s) is/are on both sides of the ramp.
- The width of the ramp/slope is 115cm (3ft 9in).
- The ramp/slope does bypass the step(s).

- The step(s) is/are located in front of the entrance.
- There is/are 1 step(s).
- The step(s) is/are clearly marked.
- The height of the step(s) is/are not between 15cm and 18cm.
- The height of the step(s) is/are 19cm.
- The going of the step(s) is/are not between 30cm and 45cm.
- There is not a/are not handrail(s) at the step(s).

- The bell is located on the wall to the left between the first and second set of doors (shown in photograph 2).

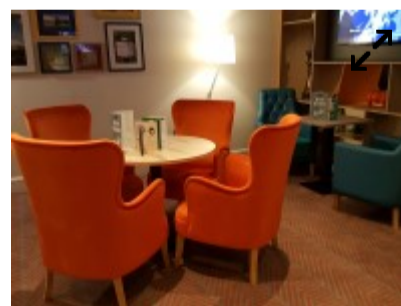
## **Eating and Drinking (Hub Bar's)**

- 
- The following information is for the bar.
  - The bar is located on the third floor, just past the reception foyer.
  - There is ramped/sloped or stepped access to the bar.
  - Full table service is not available.
  - Food and/or drinks are ordered from the service counter.
  - Food and/or drinks can be brought to the table.

- The height of the service counter is high (110cm+) .
- There is not a lowered section of the counter.
- There is not a hearing assistance system .
- There is step-free access within the bar.

- The bar is on a raised area.
- There is seating in front of the raised area that can be used and overcomes the ramp/steps (shown in photograph 6).
- QR ordering also available to order food and drink.

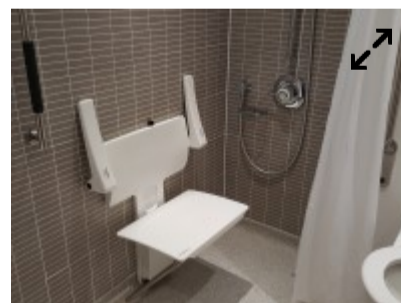
## **Accessible Room(s) (Rooms 309, 311, 315 and 317)**

- The accessible room surveyed is located on the third floor, in the rear corridor of the hotel.
- The accessible room surveyed at the time of the visit was Room 311.

- There is step free access to the accessible room surveyed.
- There is numbered signage on or near the accessible room door.
- The door is manual with a key card lock.

- The fob/card reader height is 117cm.
- The width of the door is 87cm (2ft 10in).
- There are lowered spy holes available.
- The bed type is double.
- The bed height is not adjustable.

- The height of the bed is 58cm (1ft 11in).
- The measurement between the bed base and floor is 13cm (5in).
- The bed is moveable.
- The room does have an unobstructed minimum turning space of 150cm x 150cm next to the bed.

- The height of the toilet seat above floor level is 47cm (1ft 7in).
- The toilet has a wall which acts as a backrest.
- There is a lateral transfer space.

- As you face the toilet pan the transfer space is on the left.
- The lateral transfer space is 94cm (3ft 1in).
- There is a flush, however it is not on the transfer side.

- There is a spatula type lever flush.
- There is a dropdown rail on the transfer side.
- There is a/are wall-mounted grab rail(s) available.
- As you face the toilet, the wall mounted grab rails are on the right.

- There is not a vertical wall-mounted grab rail on the transfer side.
- There is a horizontal wall-mounted grab rail on the opposite side of the seat to the transfer space.

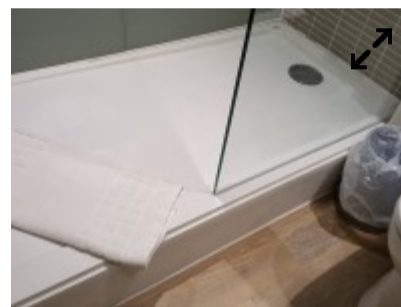
## Standard Room(s) (Room 312)

- There is numbered signage on or near the room door.
- The width of the door is 68cm (2ft 3in).
- The bed type is double.
- The height of the bed is 58cm (1ft 11in).

- The measurement between the bed base and floor is 13cm (5in).
- Light switches are not within 120cm (3ft 11in) from floor level.
- There is not an emergency alarm in the room.

- There is a deep step to access the shower created by the shower tray.

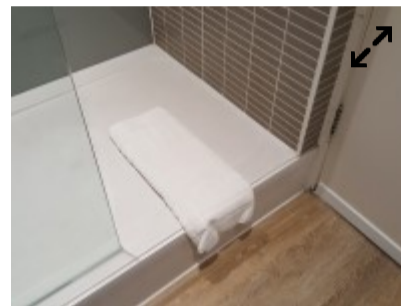
## **Standard Room(s) (Executive Room 418)**

- There is step free access to the room surveyed, via lift.
- There is numbered signage on or near the room door.
- The width of the door is 69cm (2ft 3in).

- The bed type is double.
- The height of the bed is 55cm (1ft 10in).
- The measurement between the bed base and floor is 13cm (5in).
- Light switches are not within 120cm (3ft 11in) from floor level.

- There is a deep step to access the shower created by the shower tray.

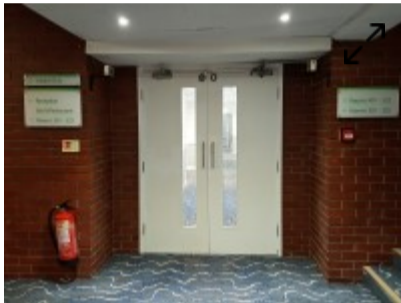
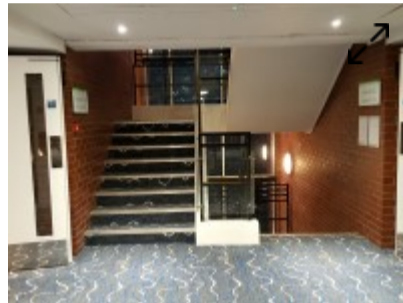
## **Other Floors**

- The stairs are approximately 44m from the side entrance.
- Signs indicating the location of the stairs are not available from the entrance.
- There are manual, double doors which may be difficult to open to enter and exit the stairwell on all floors.

- The floors which are accessible by stairs are G, 1, 2, 3, 4 and 5.
- There are 15+ steps between floors.
- The height of the step(s) is/are between the recommended 15cm and 18cm.

- The going of the step(s) is/are not between the recommended 30cm and 45cm.
- The steps are clearly marked.
- There is a/are handrail(s) at the step(s).

- The steps have a handrail on the right going up.
- Handrails are at the recommended height (90cm-100cm).
- Handrails do cover the flight of stairs throughout its length.

- Handrails are easy to grip.
- Handrails do not extend horizontally beyond the first and last steps.
- There is a landing.
- Clear signs indicating the facilities on each floor are provided on landings.
